CAPTAIN'S REPORT

TUG MACKENZIE ROSE INCIDENT

**UNITED STATES DISTRICT COURT
EASTERN DISTRICT OF VIRGINIA: NORFOLK DIVISION
Case No. 2:24-cv-00490**

CAPTAIN NICHOLAS J. LEWIS**July 2, 2025**

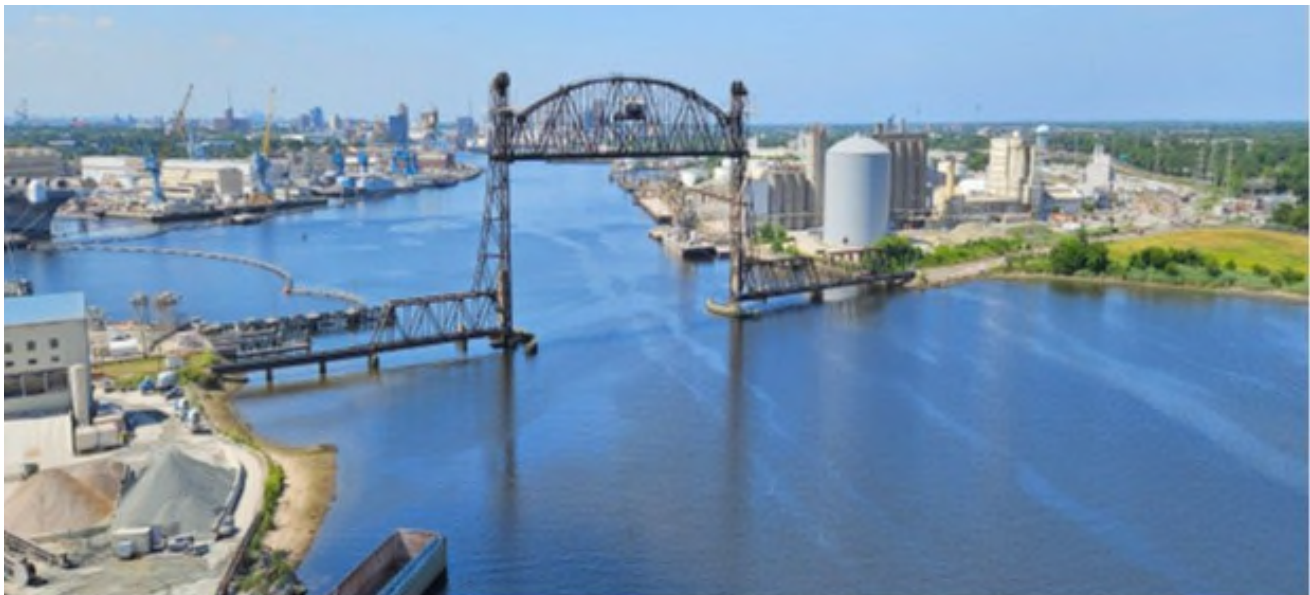
The Norfolk and Portsmouth Belt Line Railroad Company Main Line Railroad Bridge (NPBL Bridge) is in an open position.

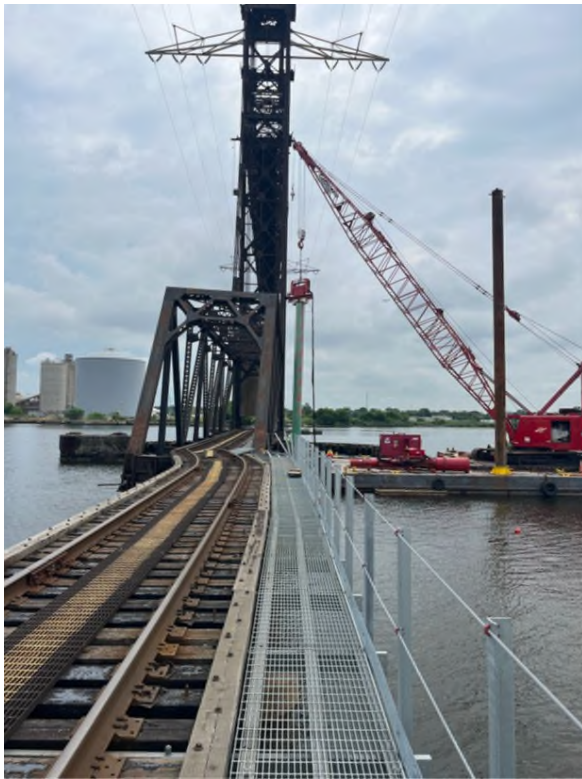
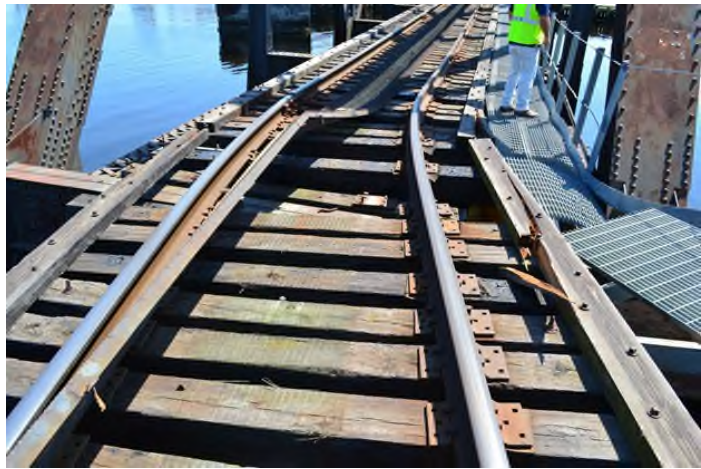
NPBL Bridge damage on June 15, 2024

1. The unit made direct contact with the bridge, causing visible structural movement (as evidenced by surveillance video), which is contrary to crew statements of “no damage” or “minor impact.”
